### Memorandum

To: Paul Baker, Utah Division of Oil, Gas and Mining  
From: Pete Sokolosky, Vernal Field Office-BLM  
Subject: Solid Minerals Related Matters – Northeastern Utah

### 3809 REPORT OF INSPECTION

# 3809 REPORT OF INSPECTION

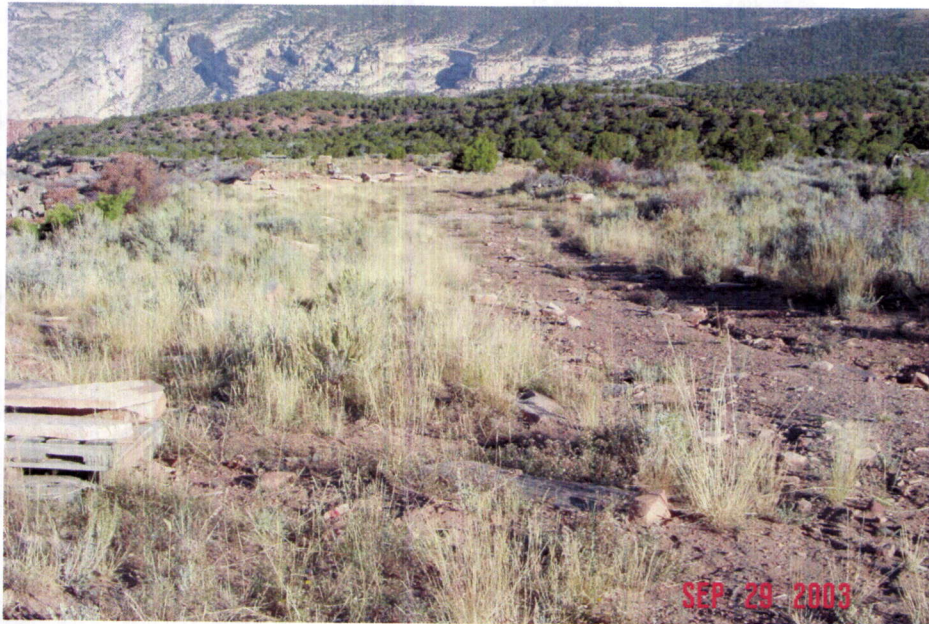
Image 2: view to north-northwest (from northeastern part of project area) of pre-existing road (note small rill at right) to quarry on east side of drainage (at upper left, stacked pallets sit in the area); there appears to have been no operations in this quarry area.

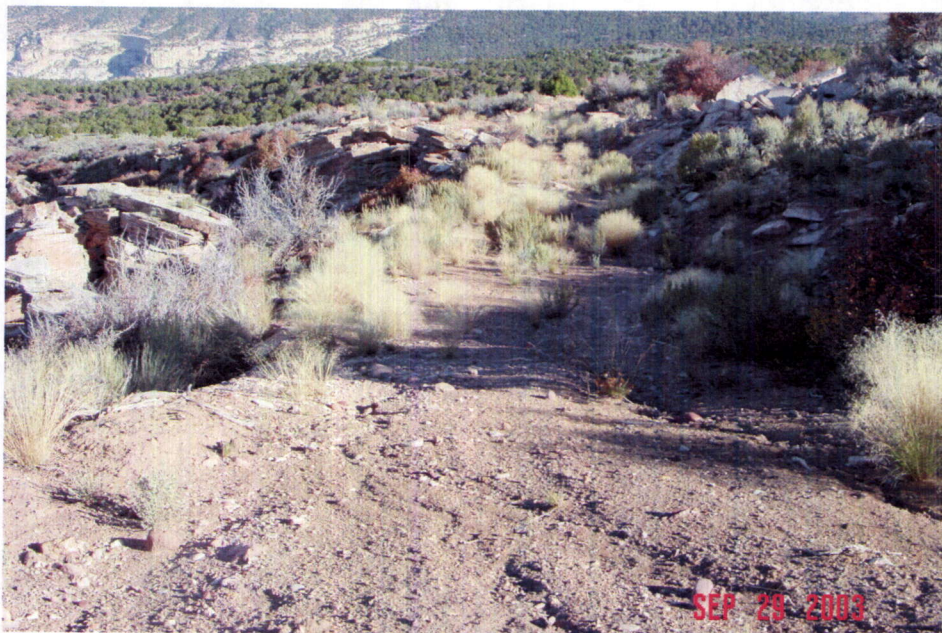
image 2: view to north-northwest (from near the south-central part of the project area) of the access road to the quarry area in the eastern side of the drainage); there appears to have been no operations in this area; some rills are forming in the roadway (due to rain a few weeks ago); image 5 below also shows another view of this quarry area.

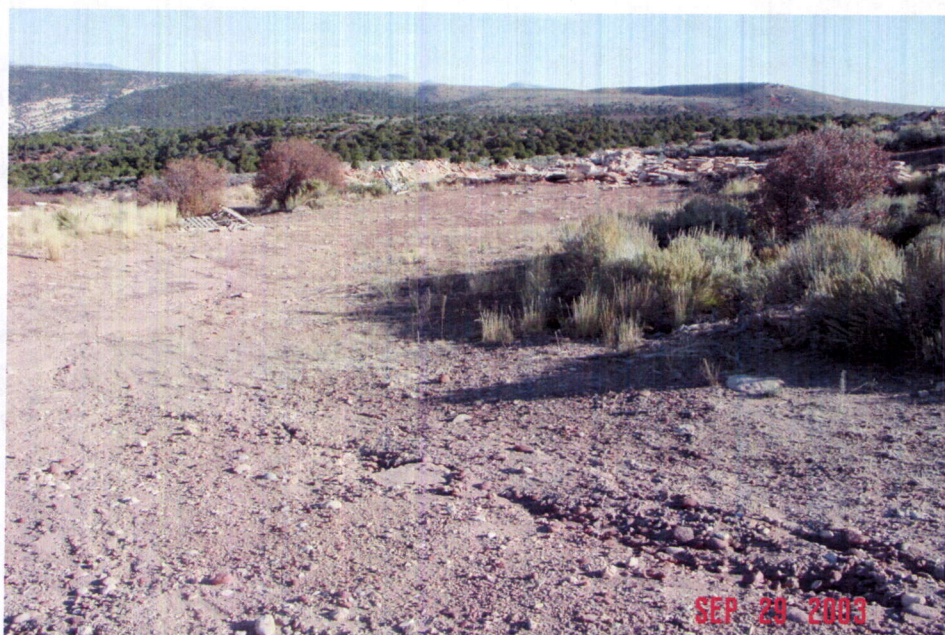
image 3: view to northeast (from southeastern part of project area); staging area and part of access to quarry on west side of drainage (rocks in background) is in foreground (note some rills in lower right).

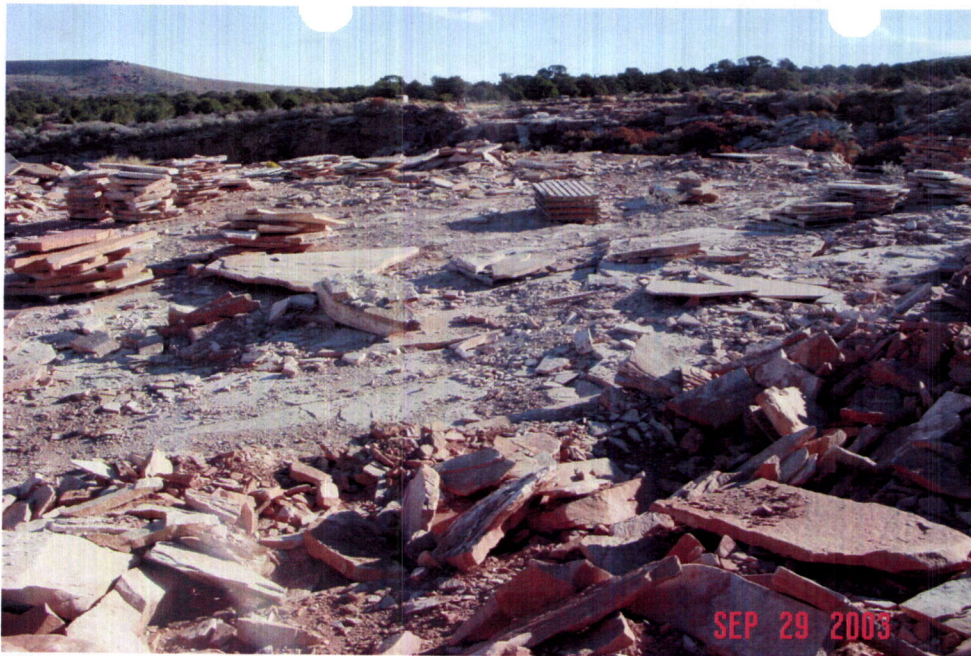
image 4: view to east of quarry area on west side of drainage; there was no evidence of operations in the area since the past inspection; quarry on east side of drainage (in far part of image 1) is in partial view (upper-center)

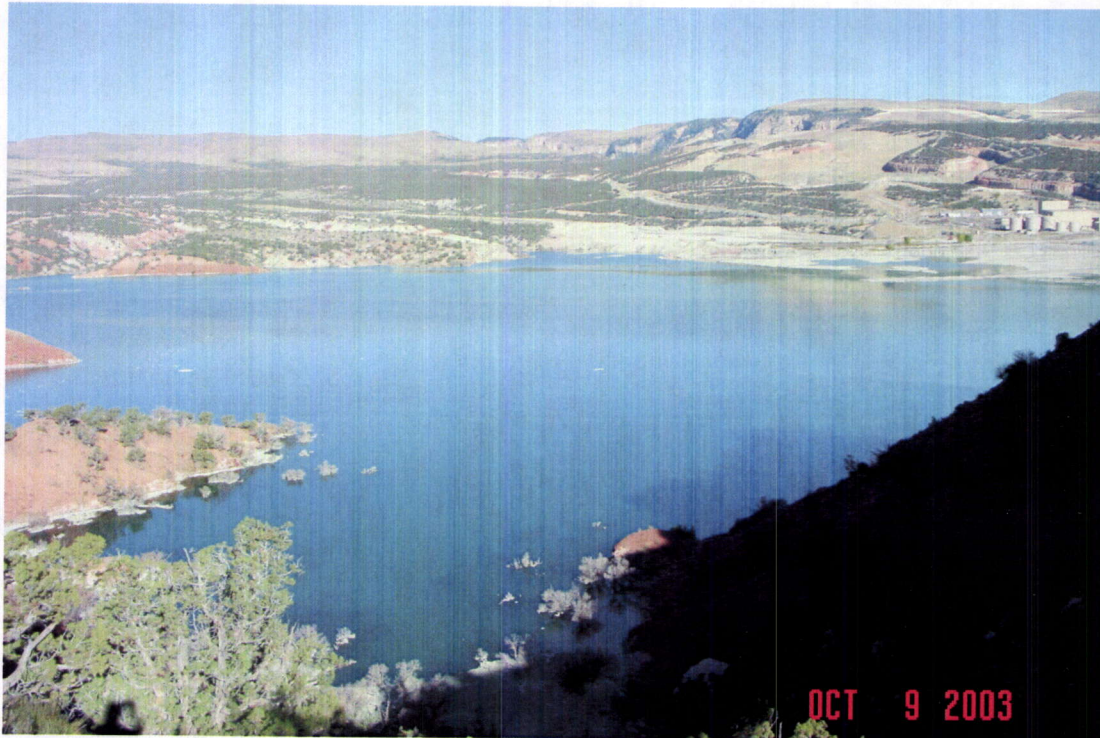
image 1: view to northwest from near northeast corner of mill site SF-13; tailings pond and south shore (middle to lower part of image); SF's beneficiation plant at right and borrow area for building next lift on tailing dam at upper-center. Reddish ground is Moenkopi Formation and light color area on far shore is top of the Park City Formation.

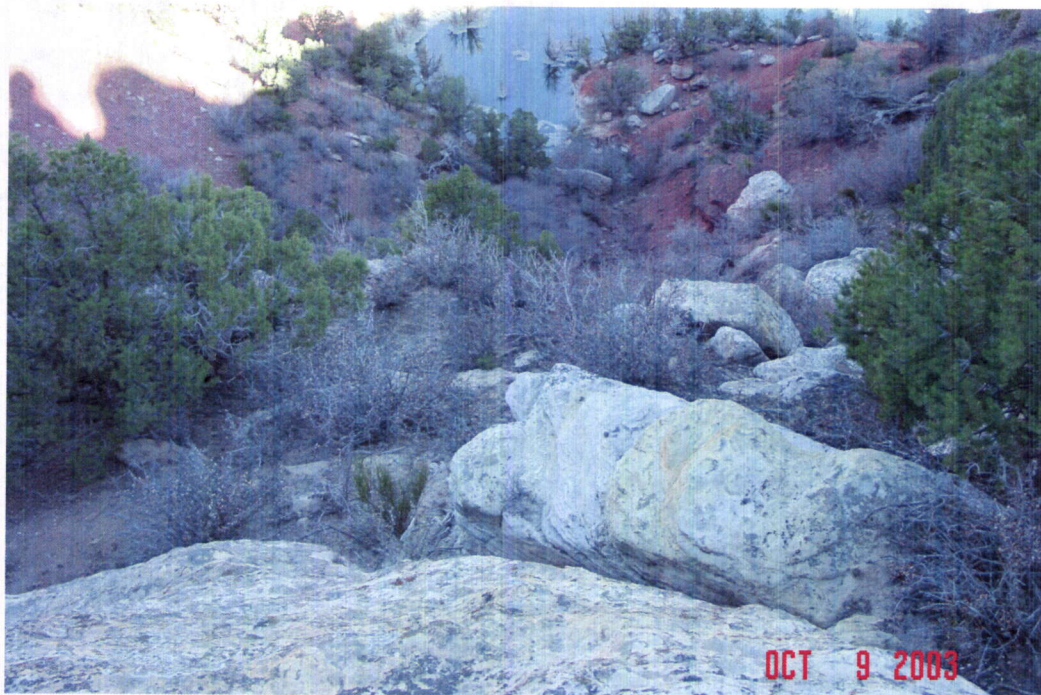
image 3: view to north  
(from about 100' south of  
the mid-point of the north  
line of mill site SF-13);  
pond waterline is about  
150' north of the mill  
site.

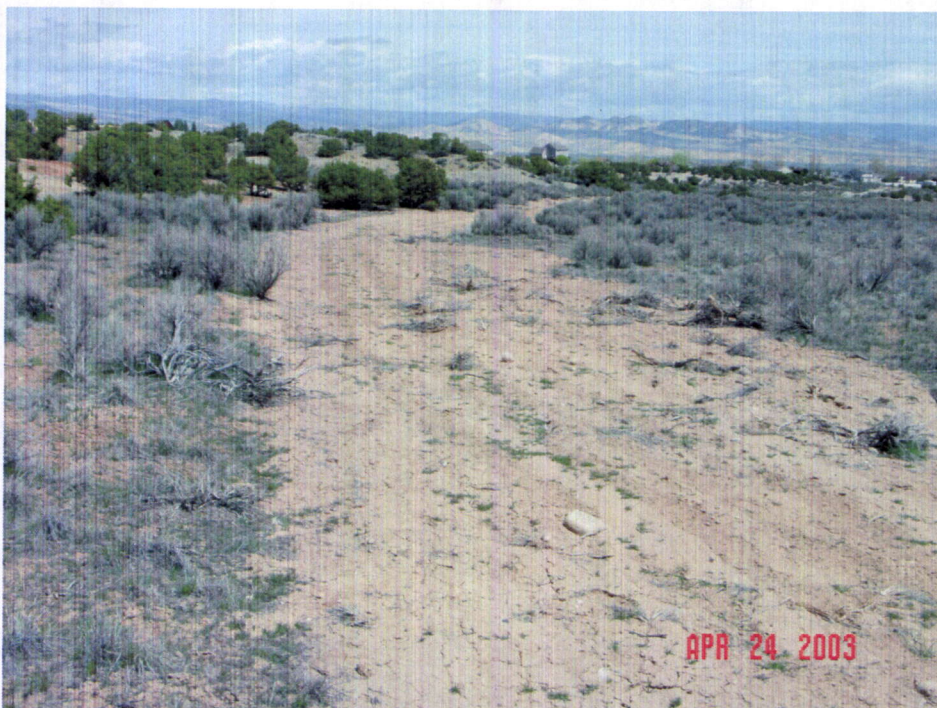
(above) view to northeast along access road that has been reshaped and seeded (opposite direction of image 7 in the 9/02 inspection); there had been [ATV] vehicular travel along this former access. Sprouts of grass are emerging.

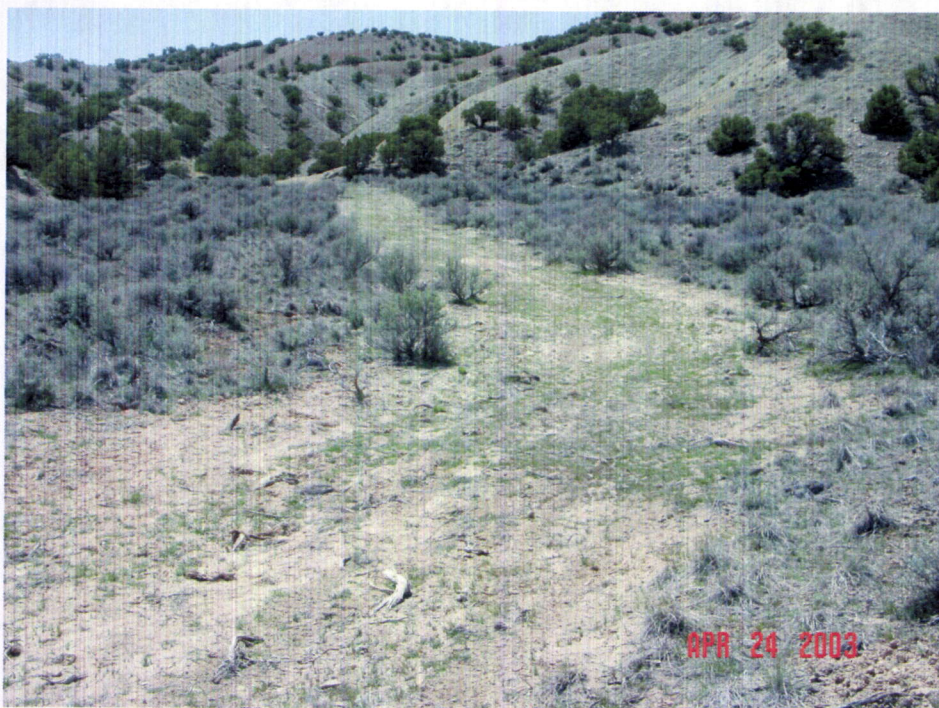
(above) view to southwest of access road that has been reshaped, seeded and has vegetation emerging (compare with image 1 of the 9/02 inspection). An ATV had traveled along the path of this former access.

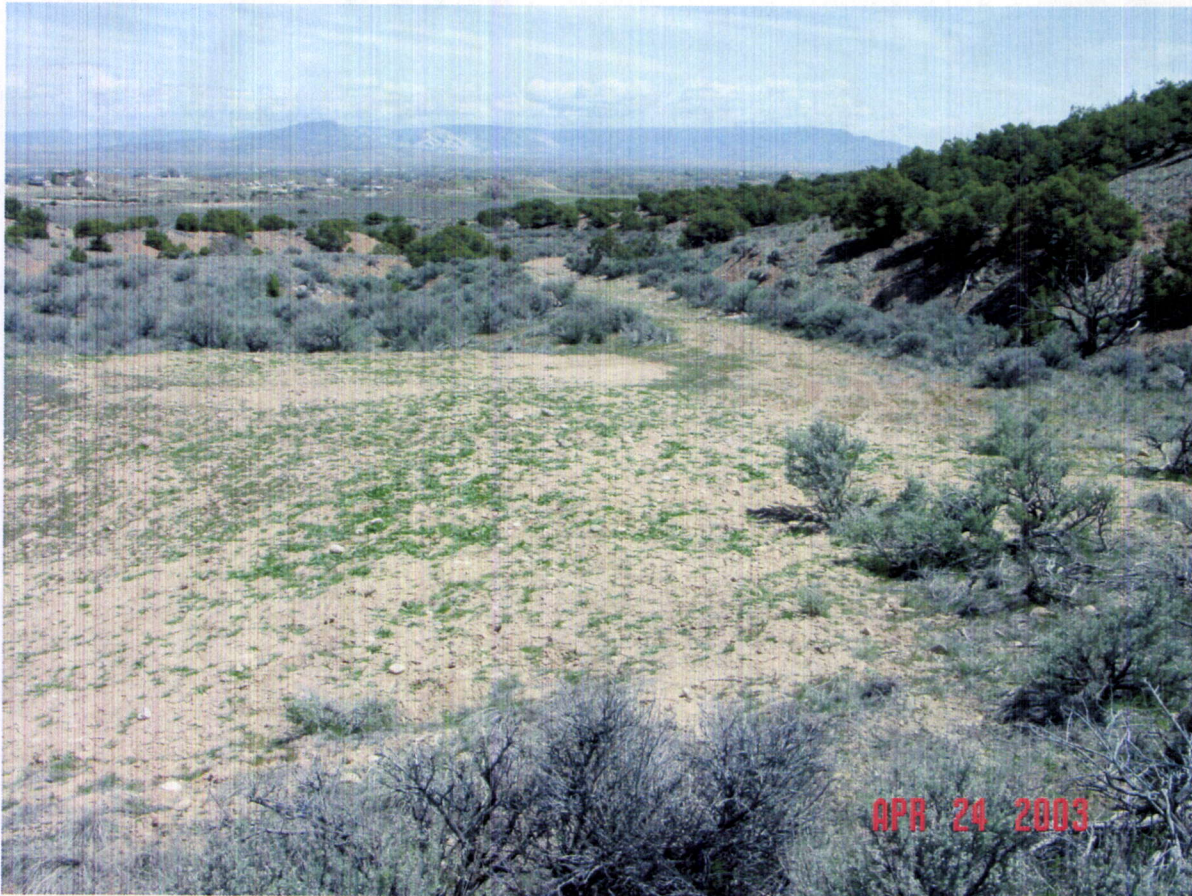
view to east – reshaped/seeded access road (upper center; ATV had traveled along its length) ends at reshaped/seeded drill pad (left-center); emergence of vegetation is notable (compare with image 2 from the 9/02 inspection)
